RAISING THE MARKER IN THE MEMORIAL GARDEN

The large marker in our **Memorial Garden** has had a problem in which water has been "wicking" up into the porous granite, causing an unsightly stain on the lower part of the marker. On April 15, 2010, in order to cure this problem, Wake Monument Company raised the marker six inches, allowing water to drain off the base and away from the marker.

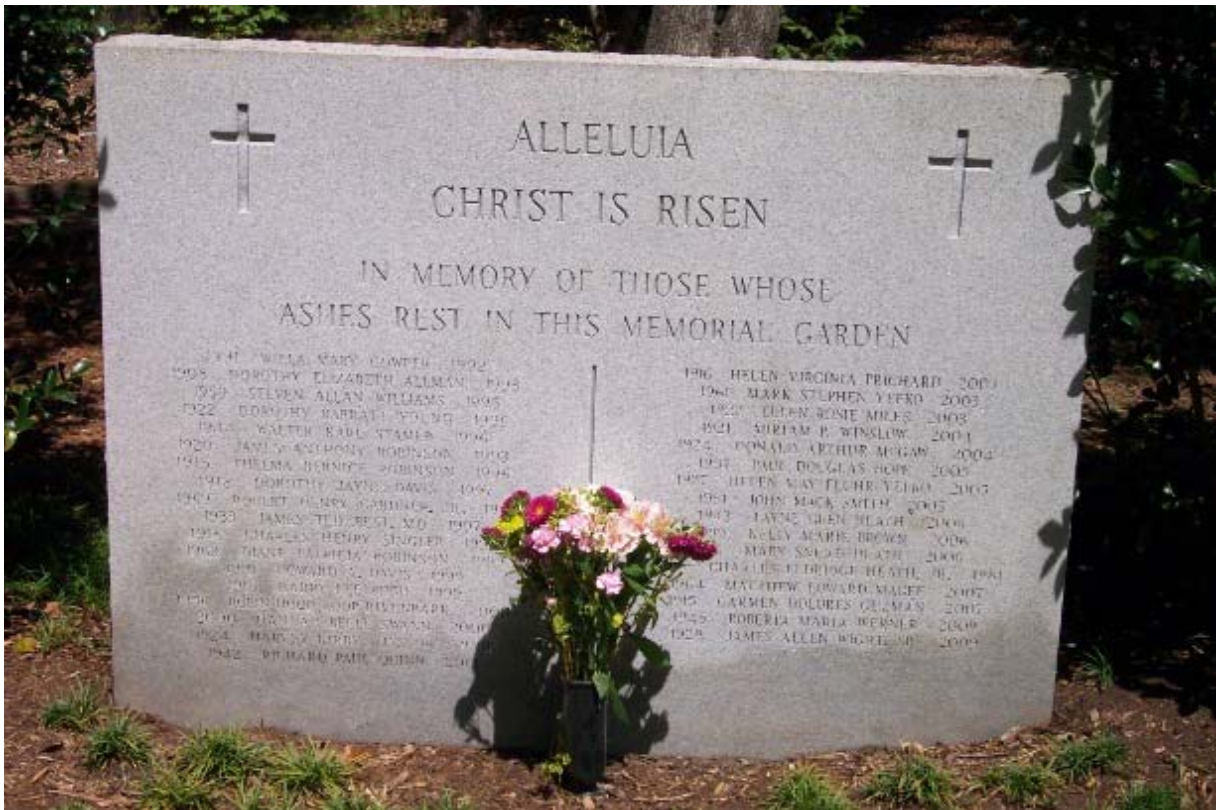
The photo below, taken earlier, shows the stain caused by the water "wicking" up from the soil around the bottom of the stone.

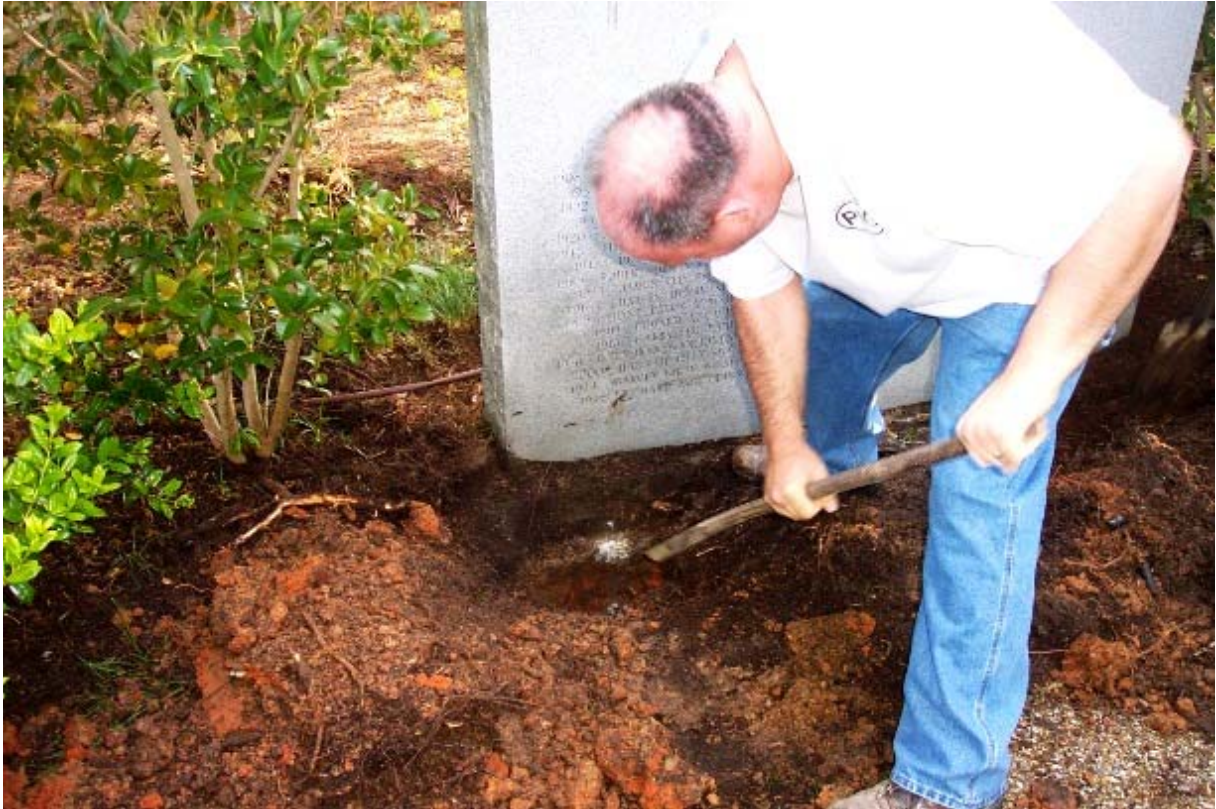
Chris, of Wake Monument Co., chips away at the old concrete foundation, laid in 1994, to make a slot into

which a jack will be placed between the granite base and the foundation.

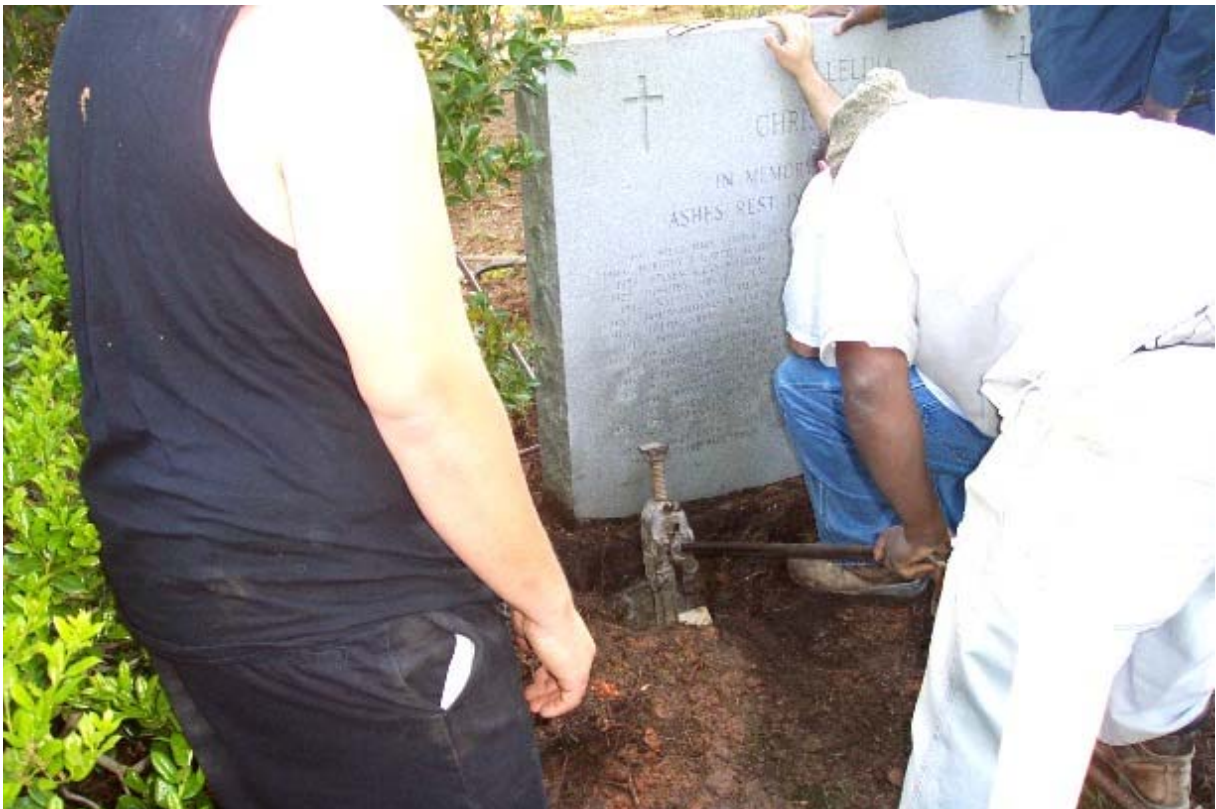
A house jack is placed between the granite base and the concrete foundation.

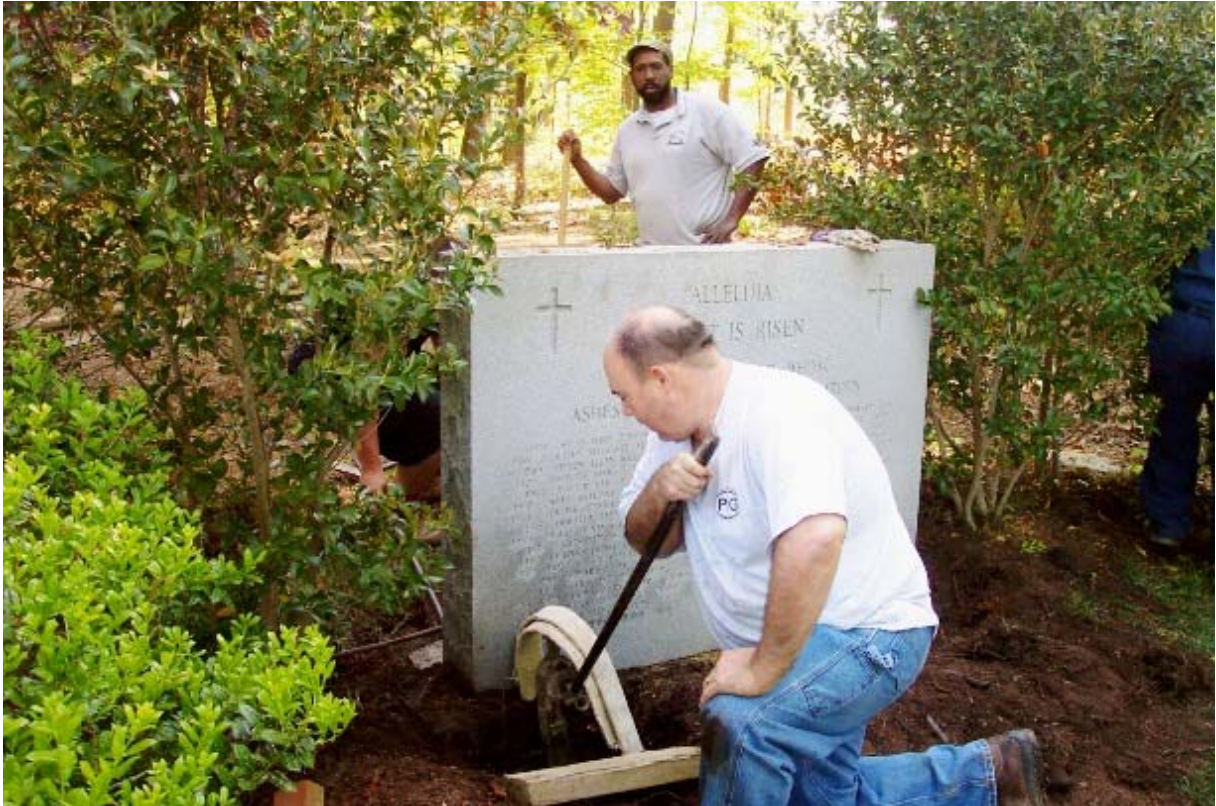
Chris jacks up the left side of the marker. Wayne (behind) waits for a space to open up so he can shovel the dry concrete in under the base. The concrete is dry now, but water will seep into it and it will harden. The white strips are padding to keep the jack from scratching the marker.

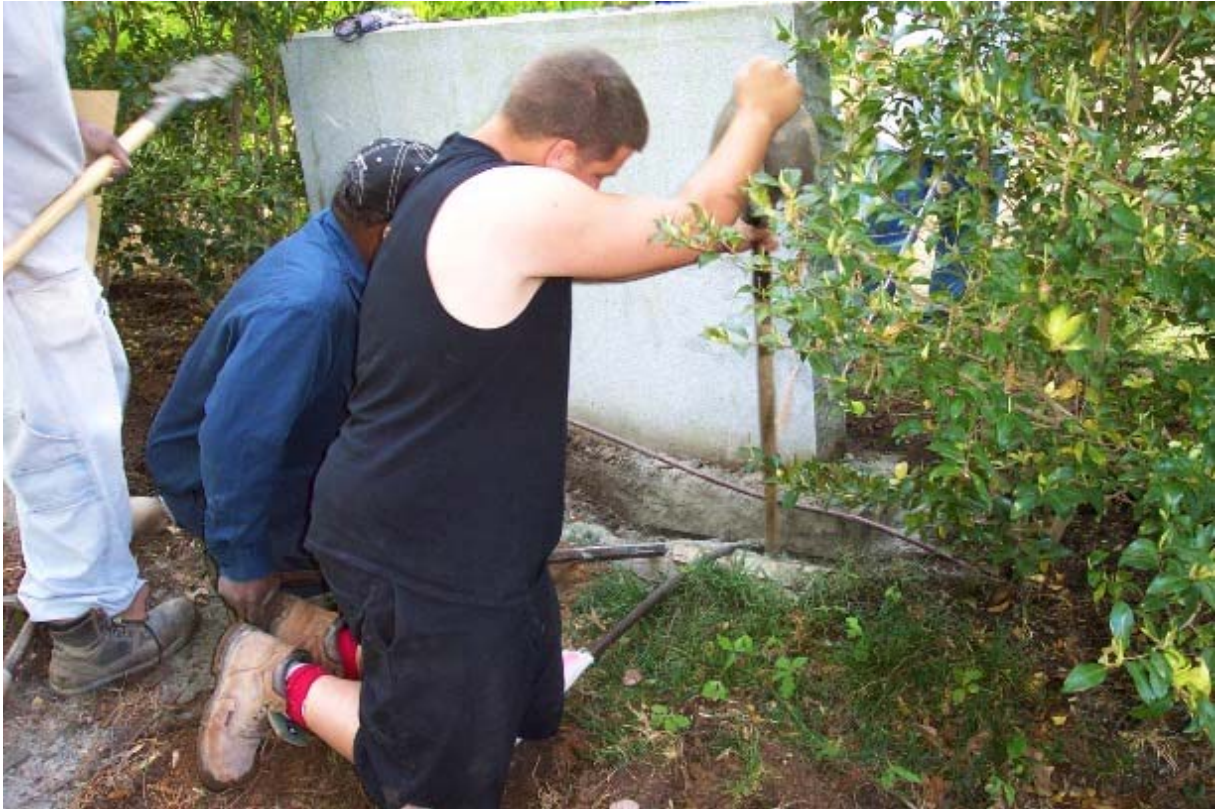
At the back of the marker, Tom (front) and James (in the ball cap) pry up the stone so Wayne (with the

shovel) can start to pack concrete under the base.

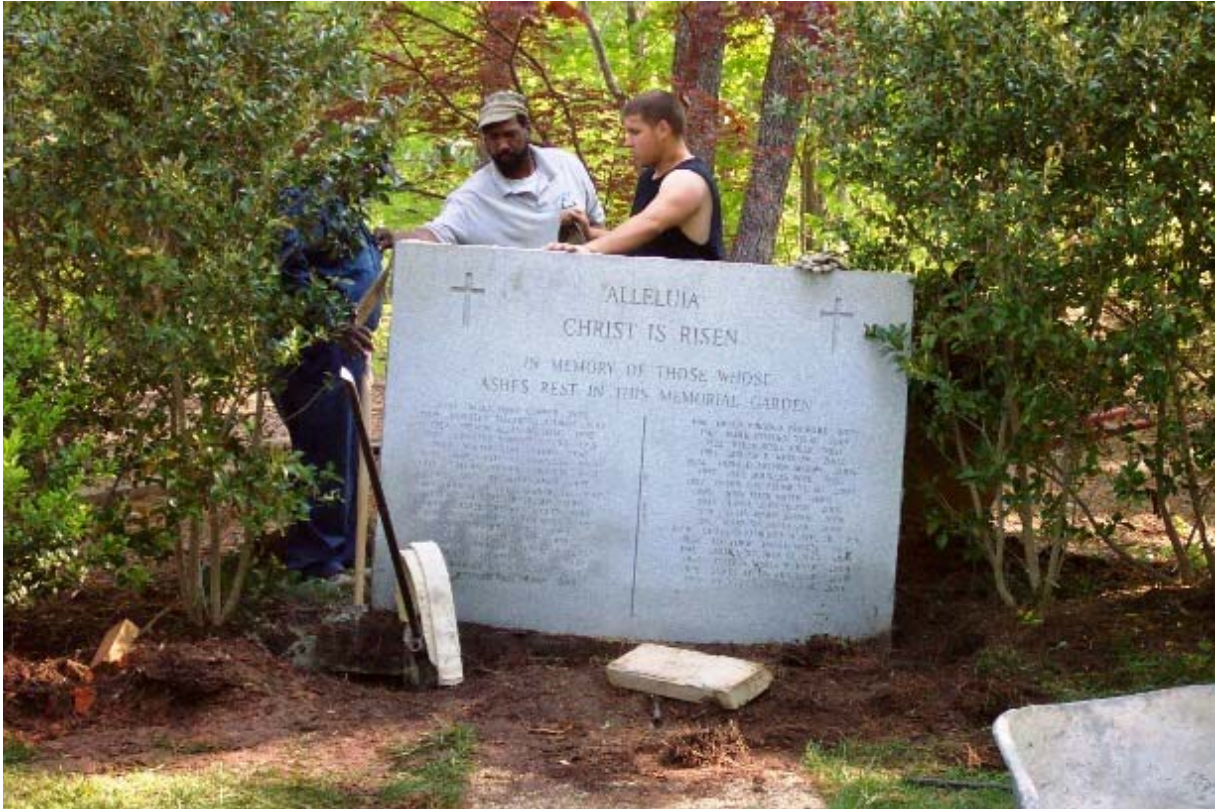
The left side has been raised six inches and packed underneath with concrete. Now they will raise the right

side.

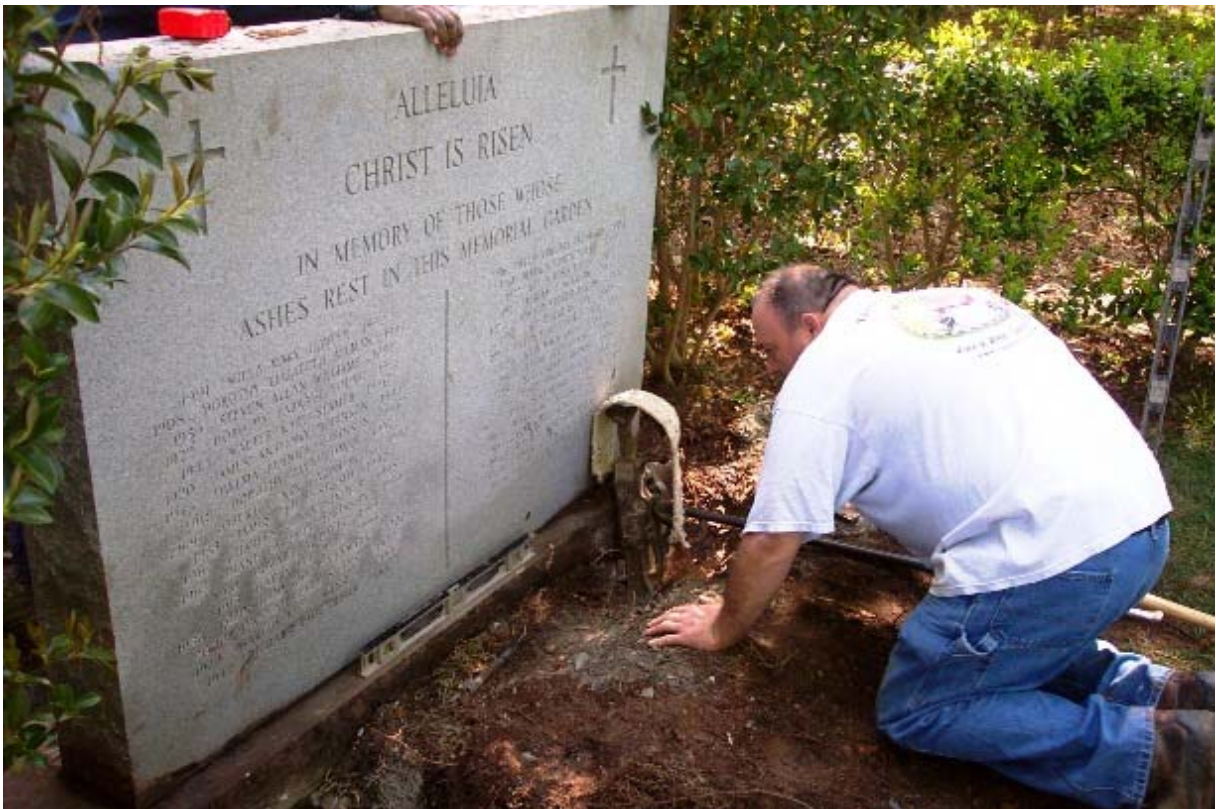
After the right side has been raised, Chris levels the marker.

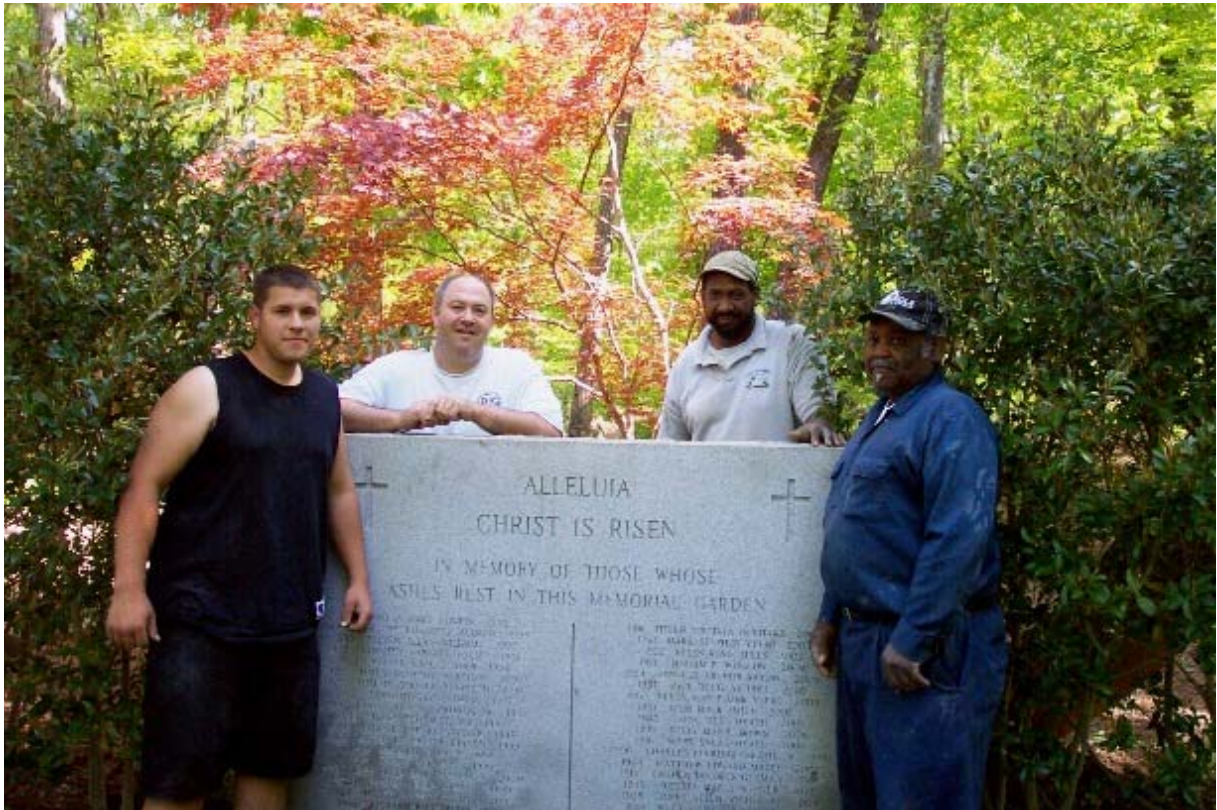
Wayne cleans the marker with muriatic acid (hydrochloric acid). This will open up the "pores" in the stone and

allow the water trapped in the stone to dry out.

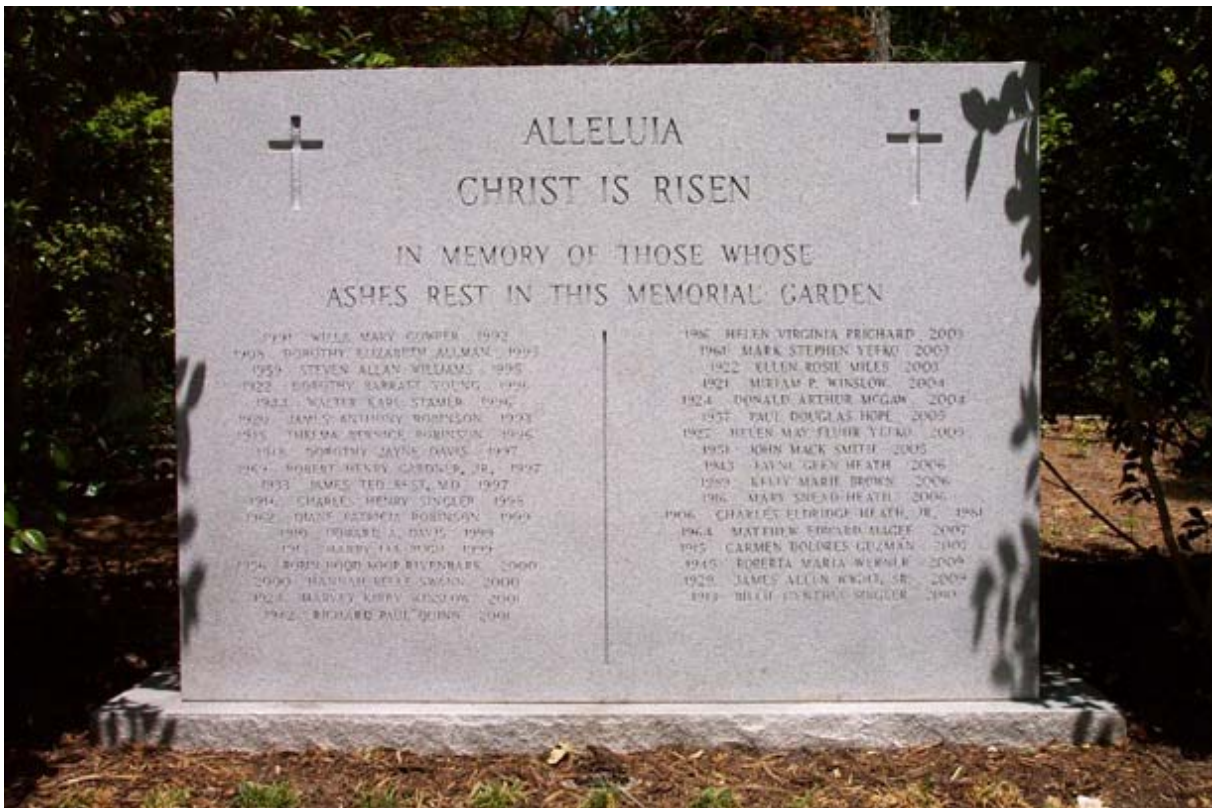
The marker on May 8, 2010.
Click the image below for a more detailed image. Zoom in to read engraving.
